## PROPERTY INSPECTION REPORT

**By:** Shelly Morgan - Inspector #6196 02/04/2014  
 (Name and License Number of Inspector) (Date)

Property Faces:	North
Structure Was:	Single Story Pier and Beam
Property Was:	Occupied
WDI Report Performed:	T0204142
Parties Present at Inspection:	None
Weather Was:	Mostly Cloudy/Windy
Outside Temperature:	Below 40 degrees
Report Number:	0204142
Inspection Fee:	\$300.00

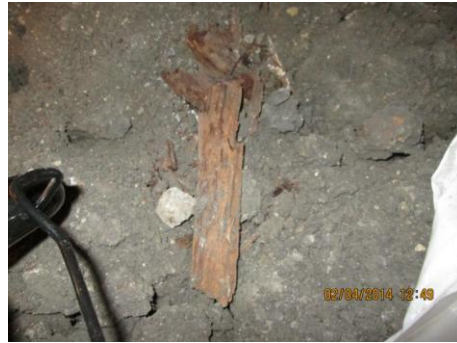
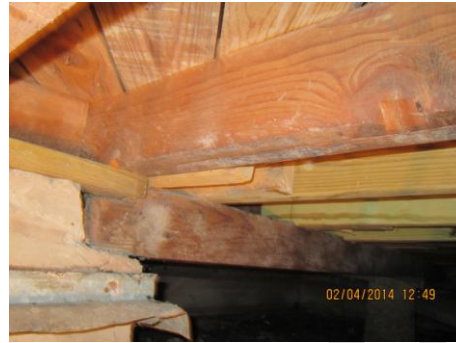
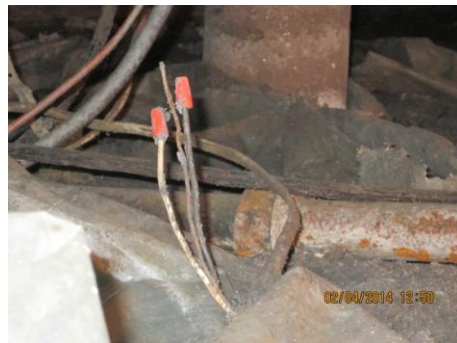
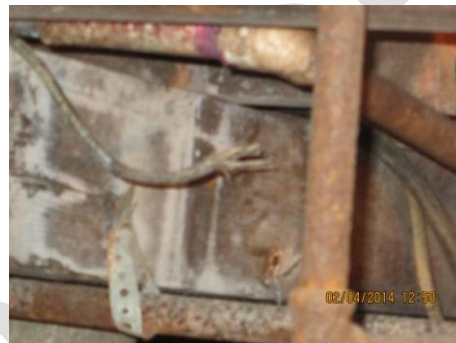
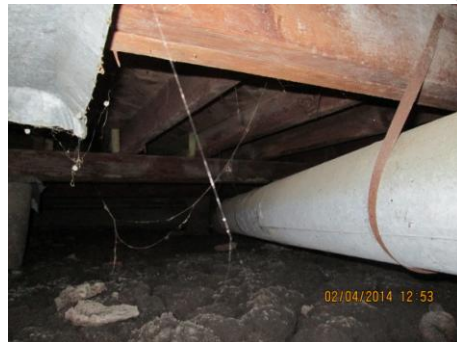
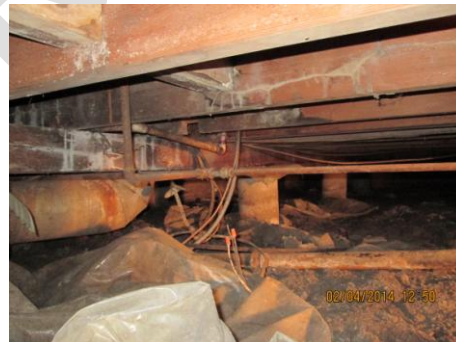
There are exposed/hot electrical wires lying on the ground under the furnace unit in the crawlspace.

Excessive termite damaged wood debris is present in the crawlspace.

Insufficient ventilation is present for the crawlspace area.

The metal a/c ducts need to be insulated in the crawlspace.

Some areas of the subfloor have signs of active water penetrations; under the furnace and master shower area.

There is an extensive crack at the exterior beam wall at the back of the structure.

There are cracks present at the concrete slab at the garage floor.

There are floor joists and/or girders with signs of termite damage.

There is a rusted gas line present in the crawlspace.

The metal ducts and Freon lines need to be insulated in the crawlspace.

Overgrown vegetation is obstructing the exterior beam wall around 50% of the structure. It is not recommended that vegetation be affixed to any concrete wall/foundation surface.

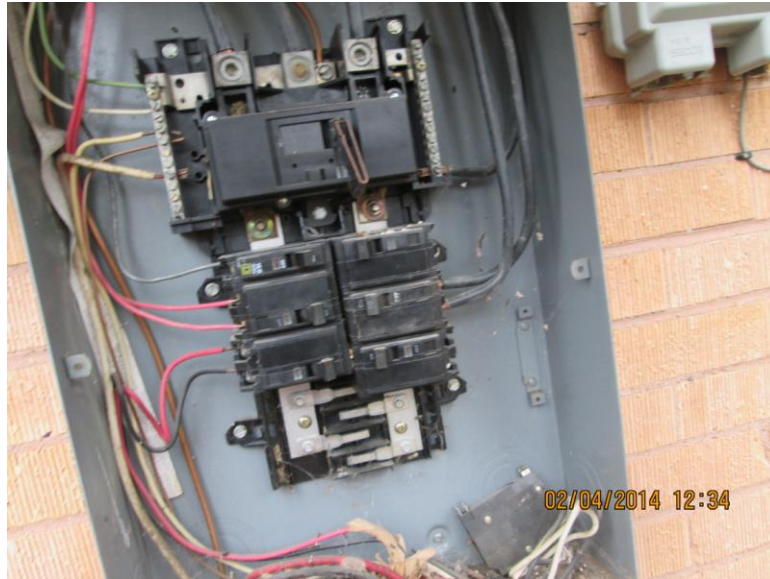
The GFCI receptacles at the kitchen countertop does not trip with the tester.

Some of the interior receptacles have open ground wires.

There are unprotected electric wires present at the back wall/street light that is affixed to the structure. That light was not test and/or may get too hot to be that close to the wood fascia.

Some of the receptacles are the old type ungrounded type.

Unprotected electrical wires need to be protected in the crawlspace, as they are directly below the condensation drain line for the HVAC unit in the crawlspace

The exterior receptacles are missing the weather tight protective covers that are now required for new construction.

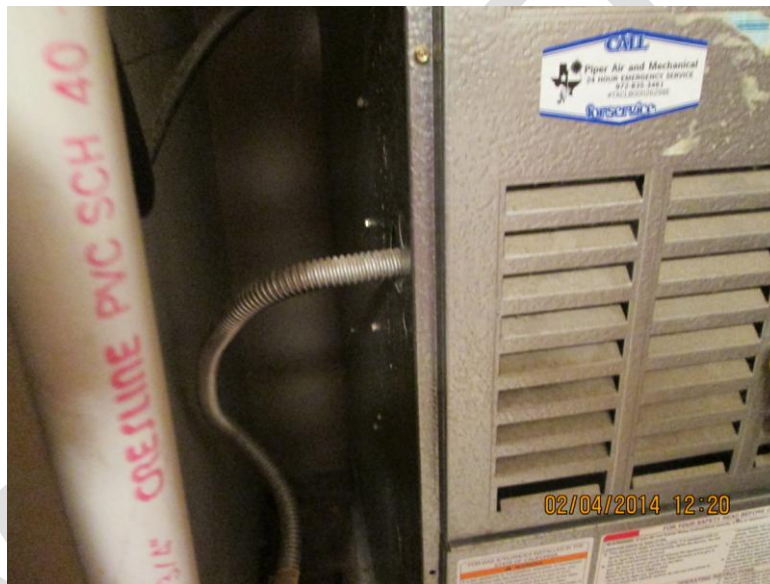
The flex gas line is unprotected where it enters the housing.

There is no fire collar at the vent pipe for the furnace.

It is recommended that a service call be performed on the HVAC System, and the crawlspace portion to ensure that all deficiencies are properly repaired.

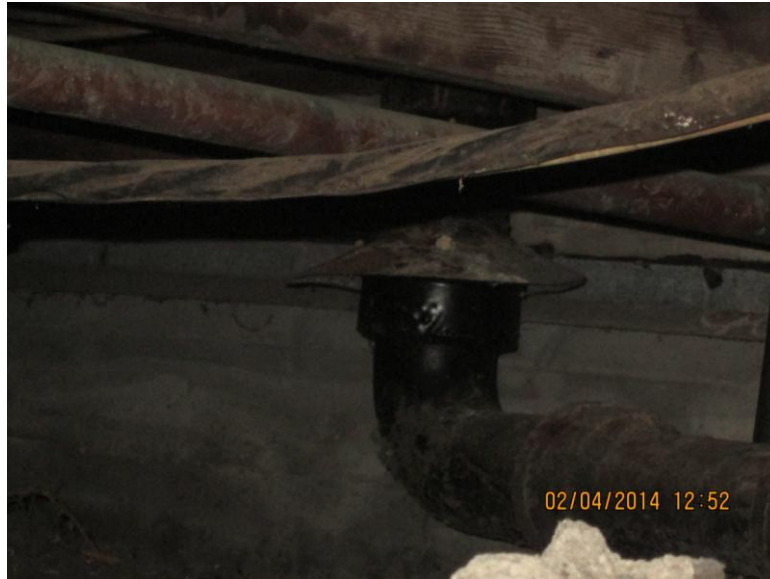
There is a sewer line leak at the master shower/bathroom area visible from the crawlspace.

Old cast iron sewer lines were observed, it is recommended that you have a licensed plumber perform a camera test to determine what deficiencies are present and what repairs are needed.

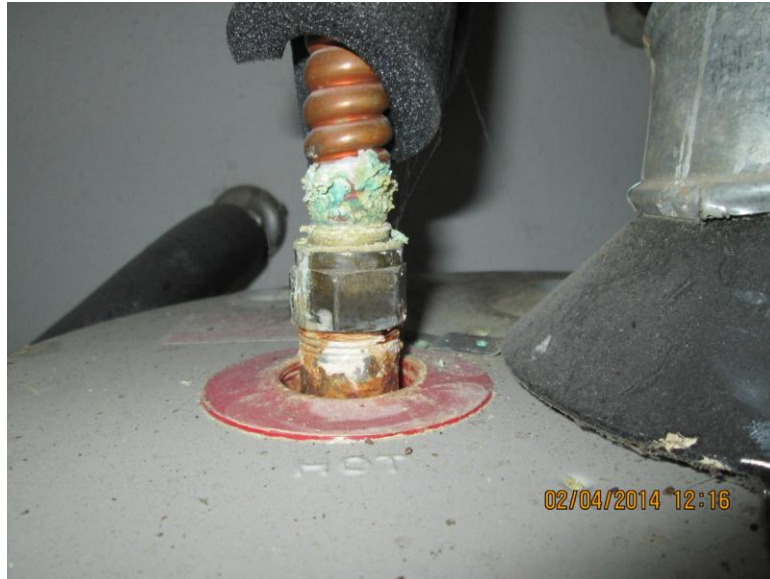
The T&P line is running up hill, it should be gravity fed.

There is rust and corrosion present on the water supply lines at the water heater.

It is recommended that you have the water heater looked at by a licensed plumber to determine what repairs are needed.

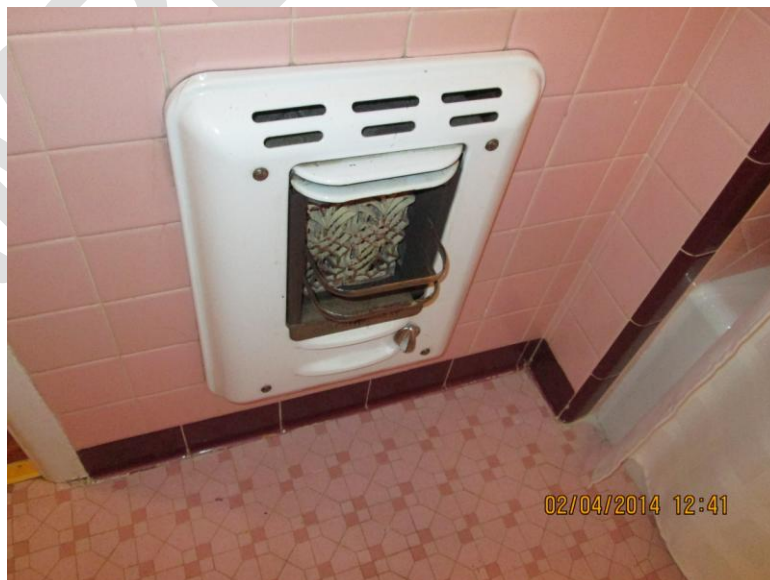
There are two unvented gas heaters present in the bathrooms. It is recommended that the be dismantled and/or abandoned for safety purposes.

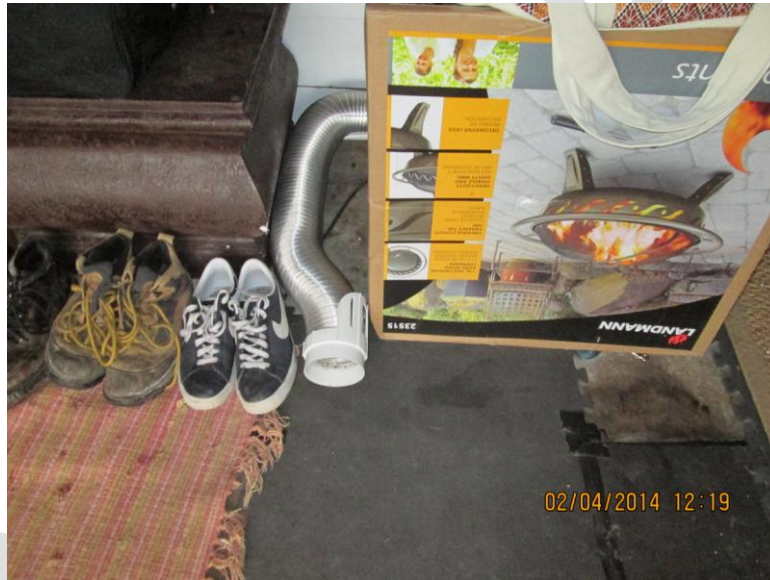
The dryer vent is terminating into the garage; it should be vented to the exterior.
