"COMMERCIAL" DUE DILIGENCE INSPECTION REPORT

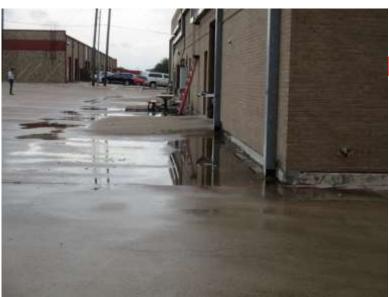
The drainage is negative and/or flat around all sides of the structure was signs of active/previous ponding present.

There is active ponding present at both back sides of the structure. The gutter downspout and rooftop drain termination locations are ponding water along the exterior foundation wall.

It is my recommendation that you consult with a drainage specialist to determine what corrective measures are needed to ensure that the foundation does not become compromised because of the drainage deficiency.

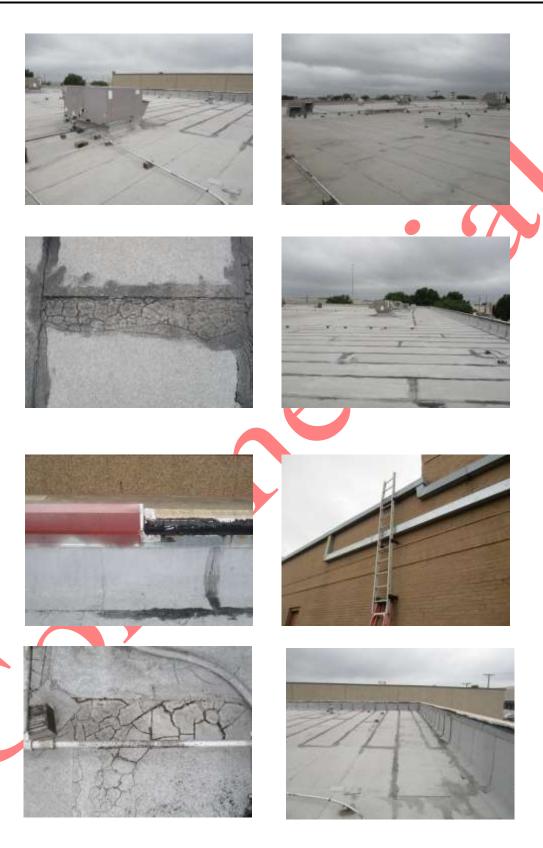
There is an improper ladder present for the rooftop access and there is no protective cage installed around the access location. It is my recommendation that you consult with the City of Carrollton to determine what type of safety violations are present with the currently installed ladder.

Some of the gutters are leaking at the seams and/or others are in need of repair.

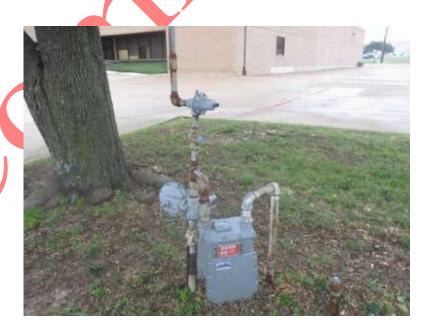
There is one gas meter located at the Southeast side of the structure. However, there are two gas lines running under the drive/parking area to the structure.

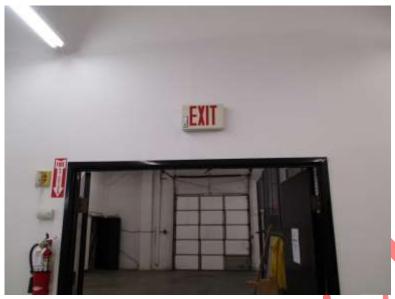
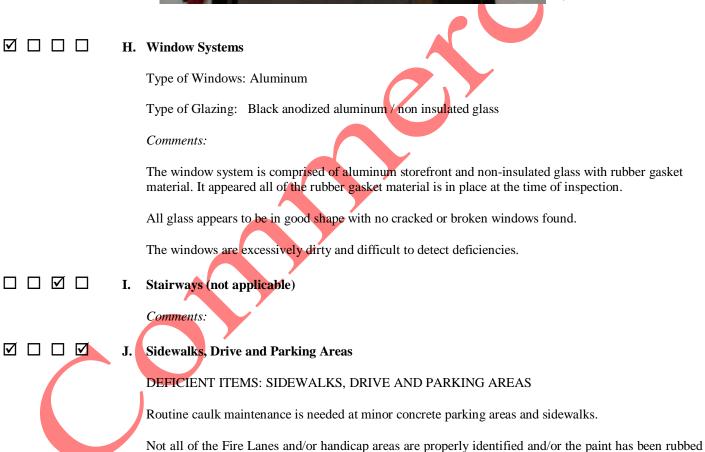
The Southwest vestibule door could not be unlocked from the inside with the thumb turn lock.

Some closures have been disconnected on some of the exterior exit doors.

Cosmetic dents and/or damaged areas were observed at most of the roll up doors.

Not all of the exit doors had illuminated Emergency Exit signs.

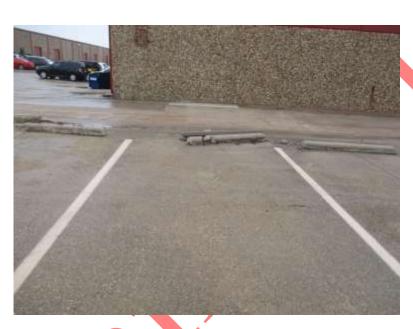
off and identification should be repainted to aid the handicapped and in the event of an emergency.

Some minor surface cracks are visible at some areas of the sidewalks and/or drive areas.

There are a couple of parking curbs that have damaged spots.

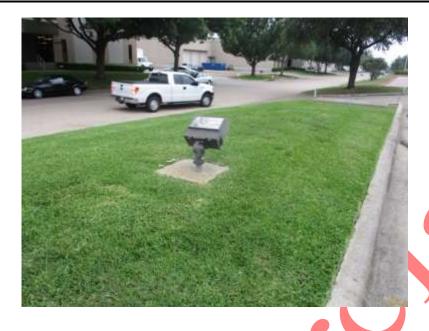
There are exterior ground lights at the front middle area of the building that were no operable at the time of this inspection. There may be a timer or it may be on a photo cell; but we were unable to get it to operate.

The exterior wall pack lighting on the East and West sides of the building did not illuminate. I recommend replacing the lamps and re-check for proper illumination.
