Inspection prepared for: PRE-OWNED HOME SAMPLE REPORT -

Date of Inspection: 1/2/2020

Inspector: Shelly Morgan

PROPERTY INSPECTION REPORT

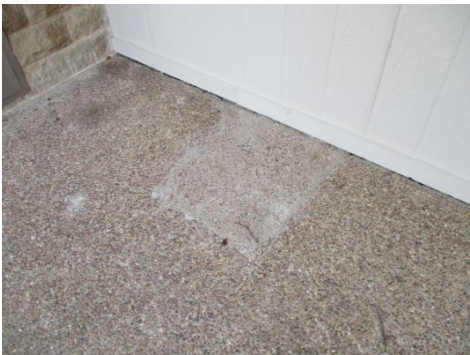
There are signs of previous repairs visible around the foundation, it is my recommendation that you consult with the seller to determine what repairs have been made. It is also recommended that you obtain copies of the pre and post engineer's reports and/or plumbing and sewer line tests to ensure that all hidden deficiencies have been repaired.

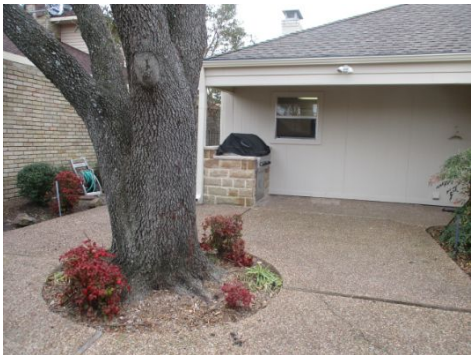
Trees and/or large shrubbery are located too close to the foundation. This could have an adverse effect on the foundation performance, roof, gutters, etc. in the future.

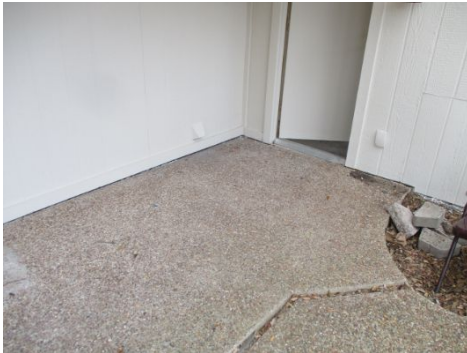
The drainage is negative and/or flat around all sides of the structure with signs of active/previous ponding present.

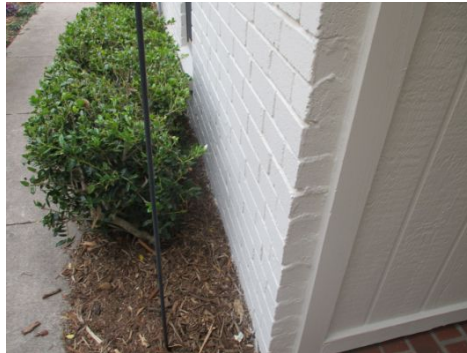
The soil line is too high around some areas of the foundation wall. Ideally you should have 2" to 4" of concrete visible at the foundation wall.

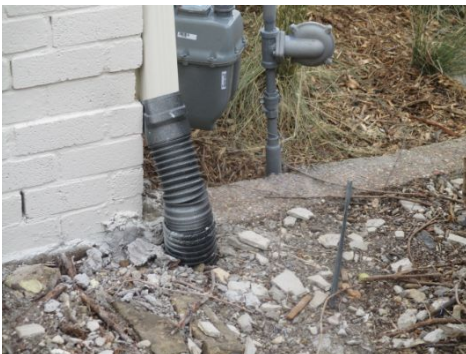
There is a subsurface drain at the left front side of the structure; I am unable to locate where it is terminating.

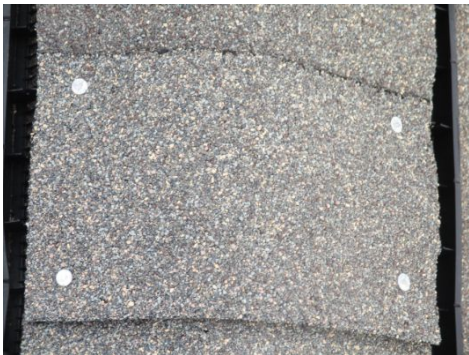
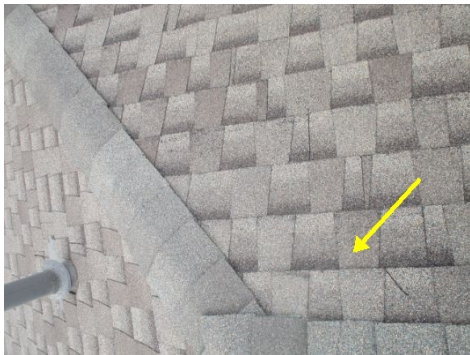
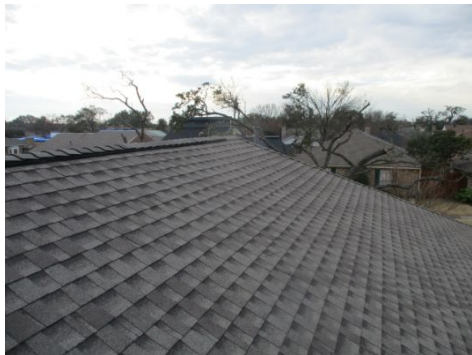
Some nails need to be sealed at the rooftop to prevent them from rusting.

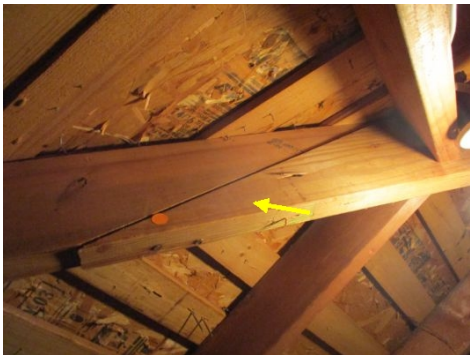
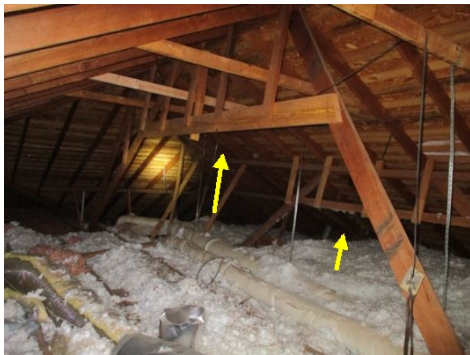
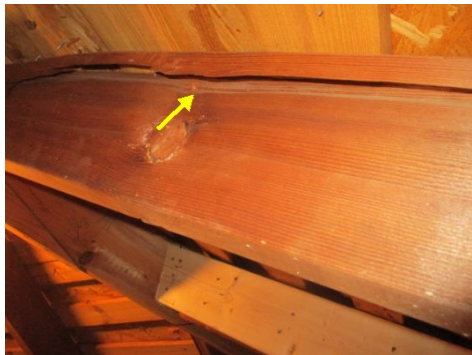
There are several cracked rafters visible in the attic area; see dots.

It is my recommendation that you consult with a Structural Engineer to have the framing members evaluated to determine what additional repairs and/or reinforcements are needed.

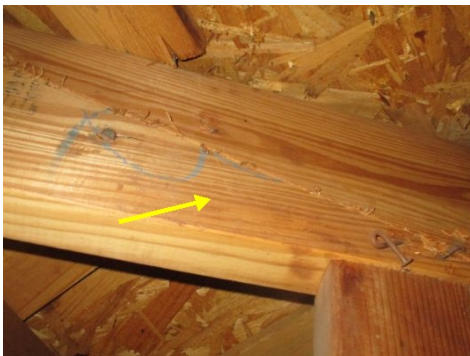
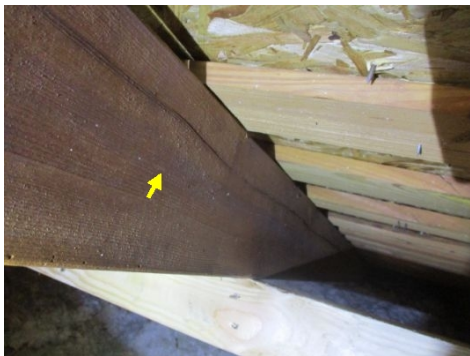
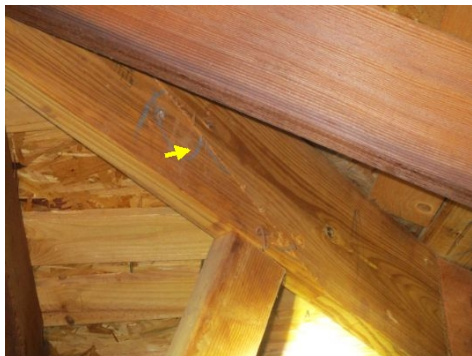
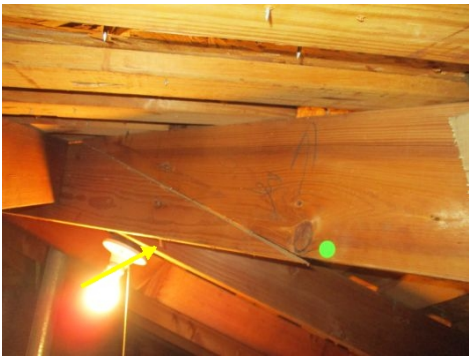
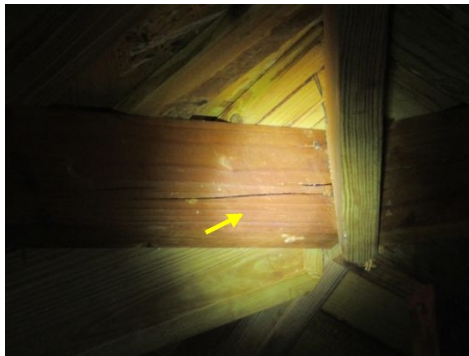
There are two areas that appear to have had additional horizontal support added, I am unable to verify if additional vertical supports are needed at those locations.

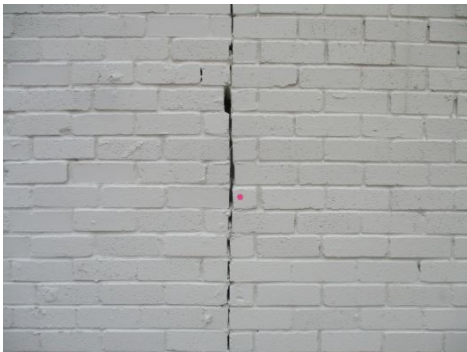
The expansion joints need to be filled in at the left side of the structure.

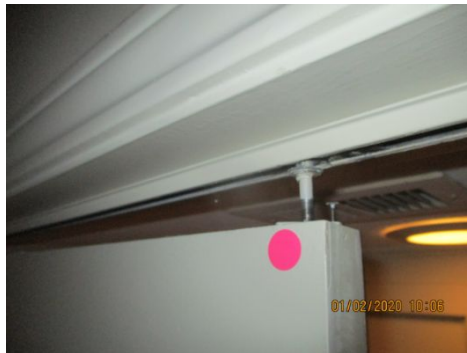
Daylight is visible at the garage exit door from the sun room and kitchen.

Some of the doors drag on the frames and others do not latch properly.

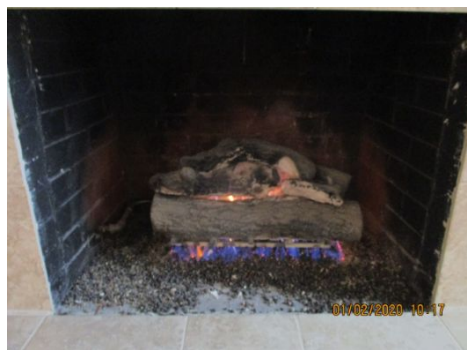
The fireplace damper operates to control and firebox appears to be in good condition, the gas starter bar operated with no leaks detected.

The chimney cap/spark arrestor are in place and secure with no visible deficiencies present.

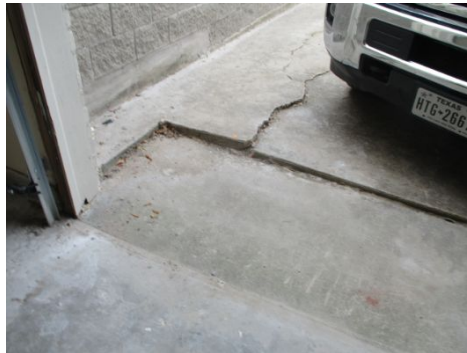
Excessive cracks were observed at some areas of the driveway; potential trip hazard and possible vehicle tire damage.

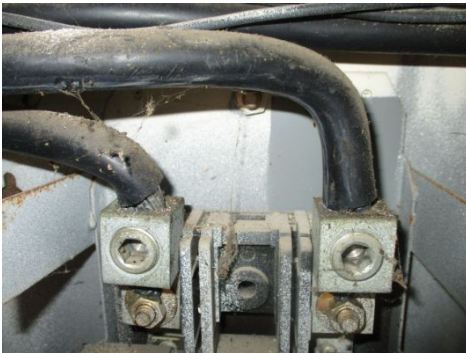
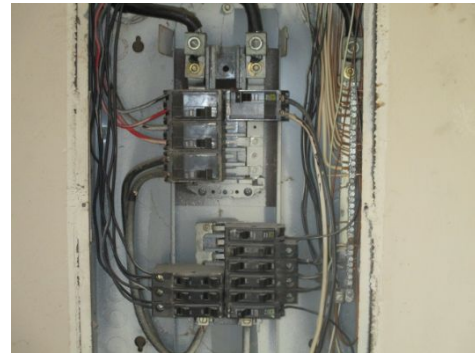
here are no antioxidants present on the aluminum wires.

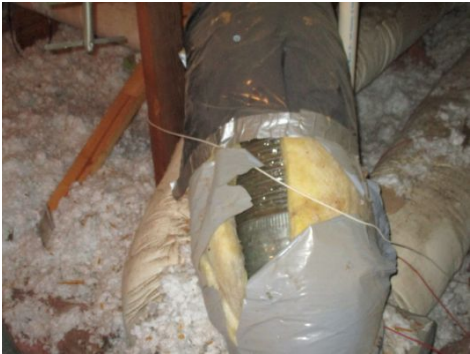
Some torn and/or damaged ducts are visible in the attic area.

The laundry room a/c vent is closed and has no lever to open it.

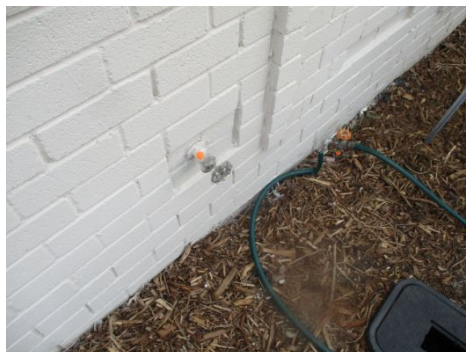
One of the front exterior wall faucets has no water supply.

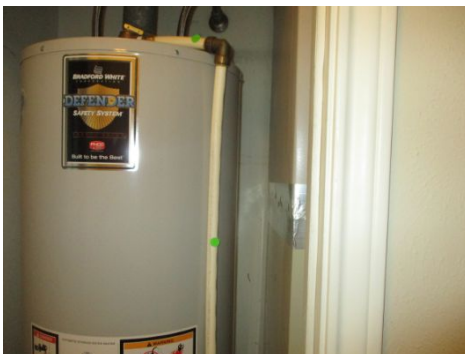
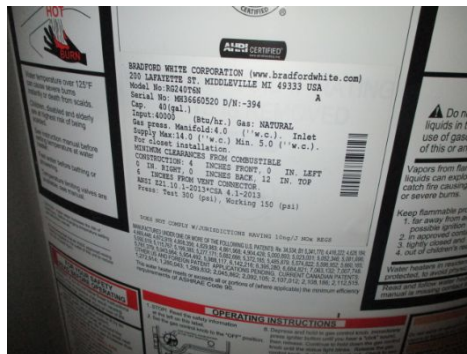
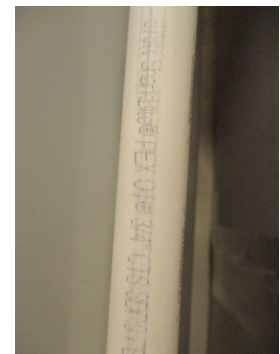
An improper material is being used for the T&P line; should be hard piped or CPVC. (Pex is not rated for this application)

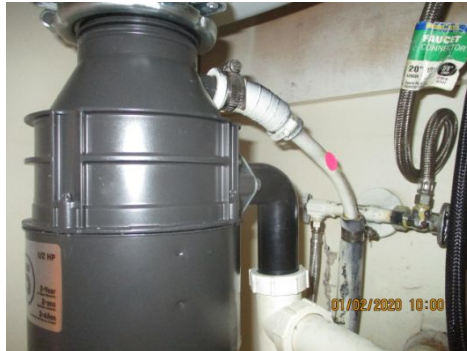
The drip loop is improperly installed; it should be high on the dishwasher side and loop down and back up to the disposer to prevent cross contamination
